Repairing the drive cone of the Yanmar SD 50

Servicing a slipping clutch

Fritze von Berswordt,
S/Y Alytes, circumnavigating 2014 - 2016

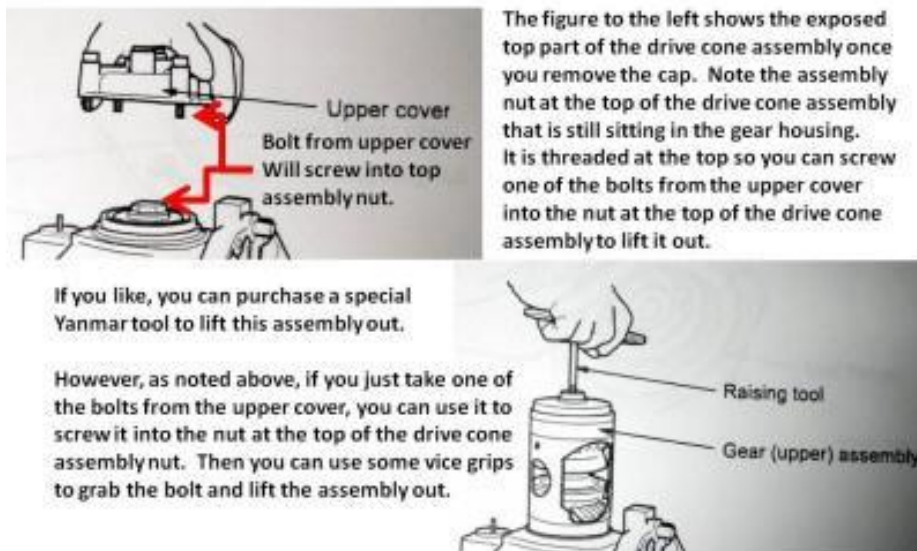
Figure 7: Step 4 Remove The Drive Cone Assembly

Figure 7 shows the exposed top part of the drive cone assembly once you remove the upper gear casing cover cap.

Note the nut at the top of the drive cone assembly which is still sitting in the gear housing in this picture. It is threaded at the top. If you like, you can go ahead and buy Yanmar's special extraction tool, however, if you are clever, it really is not needed. Instead, just take one of the four bolts that you removed from the upper gear casing cover cap (see Step 1). As it turns out, it has the identical threading as the drive cone assembly's top nut. Thus, all you need to do is screw in one of those bolts, grab it with a pair of vice grips or pliers and lift the drive cone assembly out.

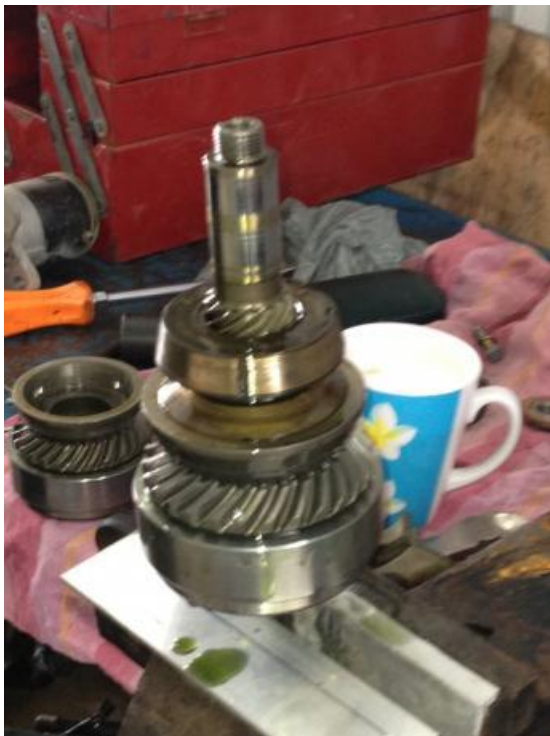
In the absence of the above, both Mark (S/V Isabella) and Fritze (S/V Alytes) used 2 pieces of aluminum section inserted into the vice jaws as shown in the pic....aluminum is softer than the spline...the spline wasn't damaged at all.

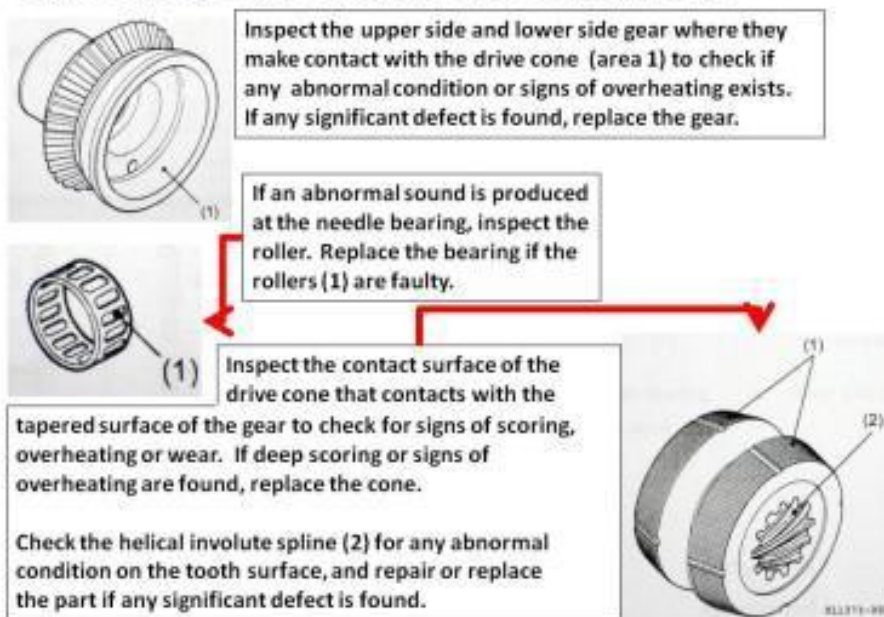
Figure 10: Step 6 Inspecting The Drive Cone And Gear

Once you have disassembled the drive cone assembly, inspect the upper side and lower side gears where they make contact with the drive cone to check if any abnormal condition or signs of overheating exists (see area 1 in the upper left hand picture in Figure 10).

Inspect the surface of the drive cone that contacts with the tapered surface of the gear to check for signs of scoring, overheating or wear (see the bottom right picture in Figure 10).

You will most likely find both the cone and the gears (Area 1 in Figure 10) smooth and glazed. That is your problem, its removal will be addressed in Step 7. But while you're at it, inspect some more:

If deep scoring or signs of overheating are found, replace the cone. Oil is "squeezed" into the horizontal grooves on the cone when it's engaged. If the ridges have been worn flat, then the cone will definitely need replacement.

Check the helical involute spline (2) for any abnormal condition on the tooth surface, and repair or replace the part if any significant defect is found (see the bottom right picture in Figure 10).

If any significant defect is found, you should consider replacing the gear. Inspect the roller (see the middle picture in Figure 10) and if an abnormal sound is produced at the needle bearing this means the rolls are faulty and the bearing needs to be replaced.

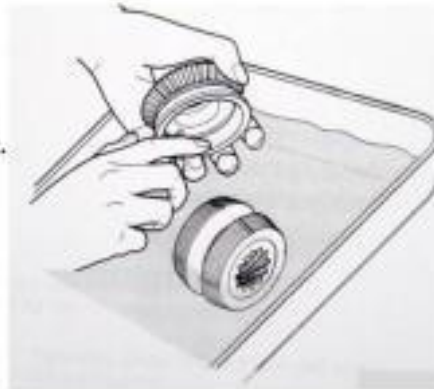
Figure 12: Step 7 Lapping Procedure For Drive Cone, Cont.

When assembling the drive cone, be sure to check its alignment. The larger diameter 044 face should be on the lower gear side.

After lapping them, wash them with kerosene or similar solvent. They need to be washed thoroughly so no grit is present.

When you are finished, make sure that you clean every part of the assembly thoroughly with kerosene, gasoline or a similar solvent. It is of high importance to get all the grit and residue from the lapping out of the assembly.
