GLOBAL TECHNICAL BULLETIN

Ref No.: GTB2009016
Date: September 16, 2009

To: All Yanmar Marine Distributors
Subject: Oil level change for SD50 series

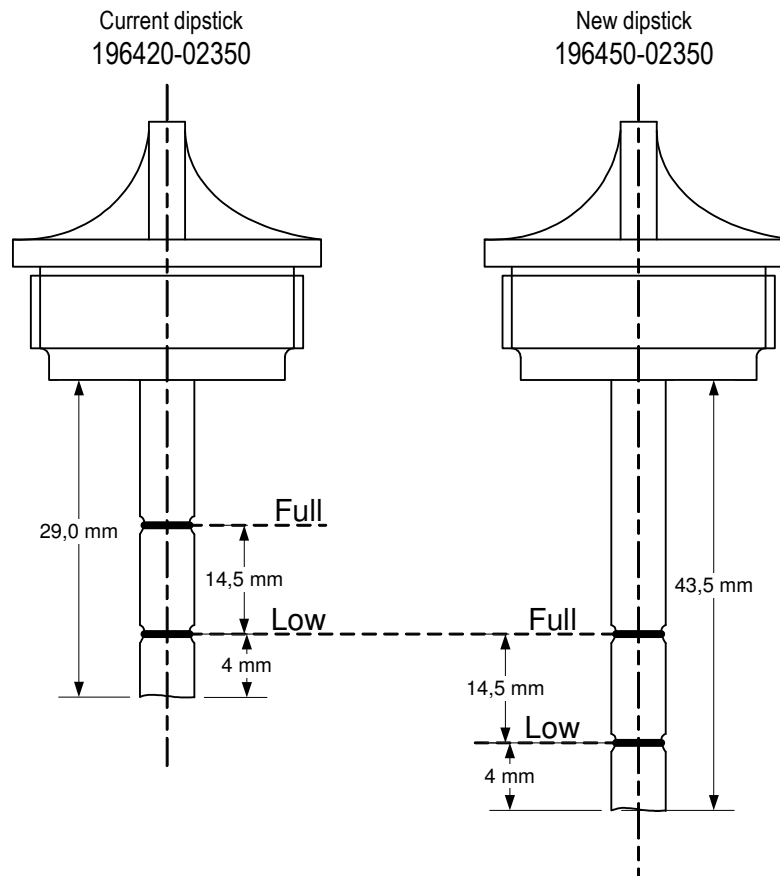
From our warranty-claim analysis, YMI has found some SD50 units with complaints regarding oil leakage at the input shaft, or where the oil was emulsified. YMI found that if our current oil-level is slightly exceeded, the inside pressure of the SD50 may exceed the proof leakage pressure for the oil seal. This can cause oil leakage at the input shaft during running, and it could suck water from the oil seal on the propeller shaft as well.

In order to obtain a lower oil pressure inside the drive, the maximum oil level has been changed from full position to low position on the dipstick.

[The difference is 14.5 mm on the dipstick]

The part number of the dipstick of the SD50 series has been changed from 196420-02350 to 196450-02350

- Please check the oil-level in the SD50 during regular maintenance.
- Correct the oil-level in the SD50 according to above specifications. If above newly recommended level; please remove oil to make the adjustment.
- If the oil-seal from the input-shaft or propeller-shaft is still leaking after correction of the oil-level, please replace the oil-seal.

Remarks: Dipstick is very short, so no possibility to put new low-level mark on current dipstick. Please use current low-level mark as new high-level mark for correct oil-level.
