The Westerly Owners' Association

The Volvo 2000 Series Gearbox Problem

Collated by Eric Hyett & Mike O'Brien from various sources with contributions from Jack Cairns, John Mathias, Walter Reed and many others. Apologies if you contributed and haven't got a credit.

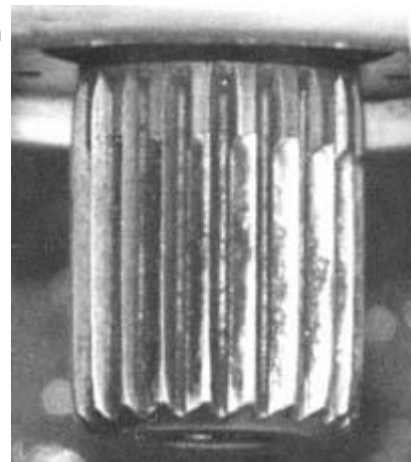
The photo on the right shows serious wear typical of this problem

3. Over the course of time, the splines can suffer damage and wear, so that the splines no longer engage, and all drive is lost.
4. It is not possible to determine the extent of spline wear without removing the gearbox.

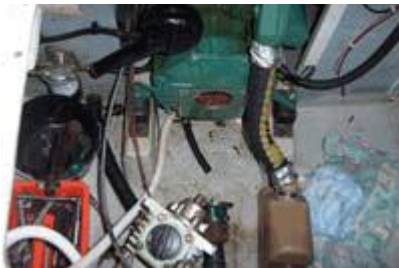
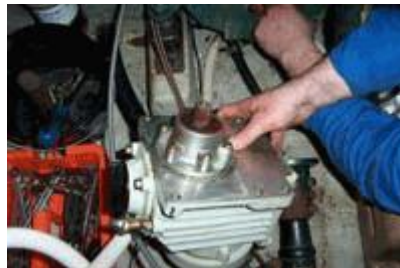
Gearbox detached from the engine and the position of the splined drive shaft

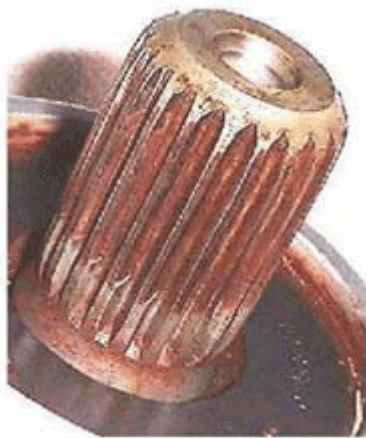
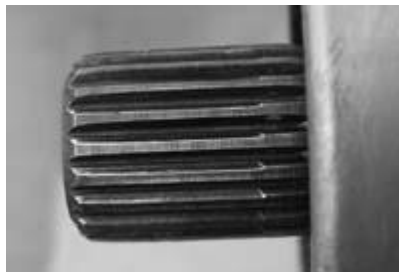
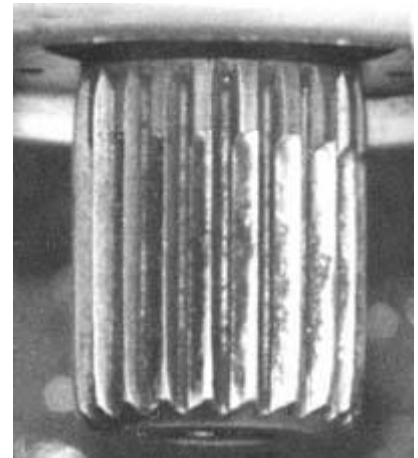
Examples of the worn splines

These splines carry the drive from the engine to the gearbox (and of course to the propeller) and have been reported to have failed suddenly and without warning on yachts as young as three years old. The result is complete loss of drive. The wear shown here is after 1611 indicated engine hours. The splines have become saw teeth like in profile and the interior is covered in thick red rust dust. The same wear is present on the flywheel plate. This gearbox was inspected as a precaution, not after failure. There were no symptoms.

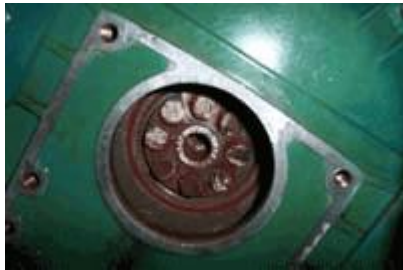
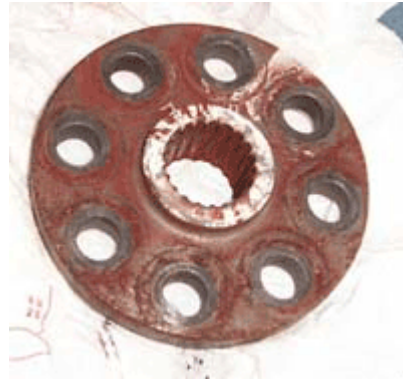
These spline shaft engages with a plate bolted to the flywheel shown in place and removed

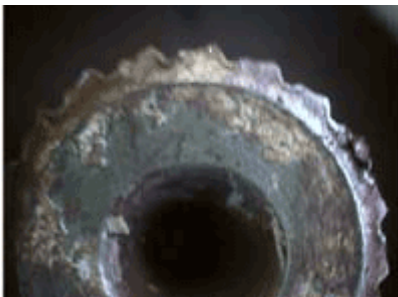
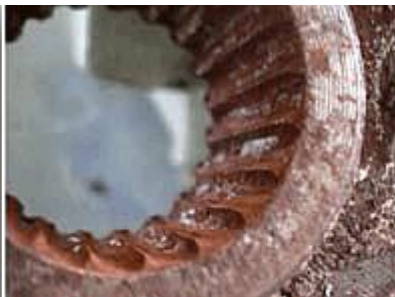
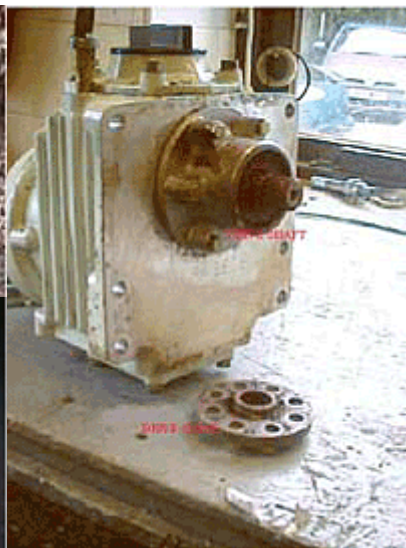
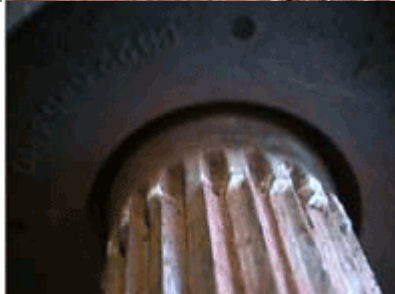
Here is another set of photographs showing the same wear. They were taken after 1449 hours on the meter and show the second failure on this installation since new in 1987. The first failure occurred under previous ownership without warning in 1990. Thanks again To Mike O'Brien for these four pictures of wear.
