1979
**FASTNET RACE
INQUIRY**

ROYAL YACHTING ASSOCIATION • ROYAL OCEAN RACING CLUB

REPORT

THE COUNCIL OF THE RYA AND THE COMMITTEE OF THE RORC

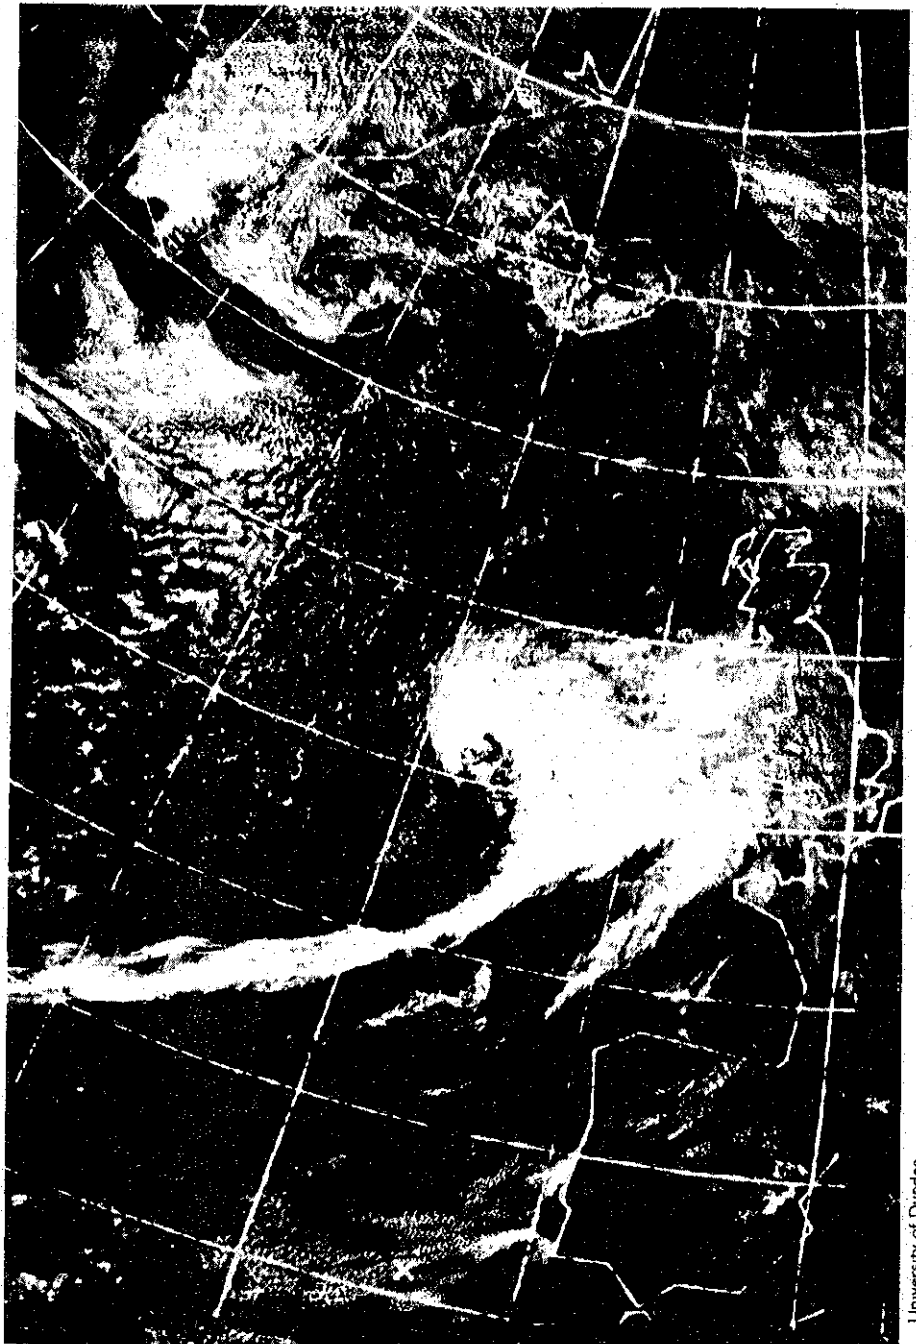
Fig. 3. How the TIROS N satellite saw the Fastnet low at 1637 on Monday. Reference to Fig. 1 will show where the low centre was at this time. The long tail of cloud lies along the cold front while thick cloud covers the centre off Ireland

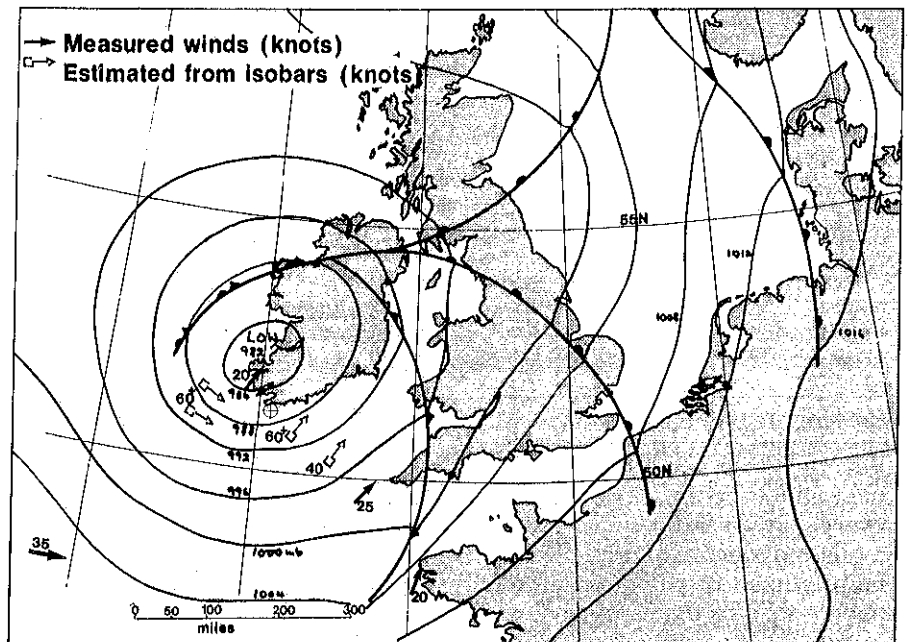
Fig. 5. The storm corridor develops with surface winds above 60 knots off the Fastnet (0100 Tuesday)

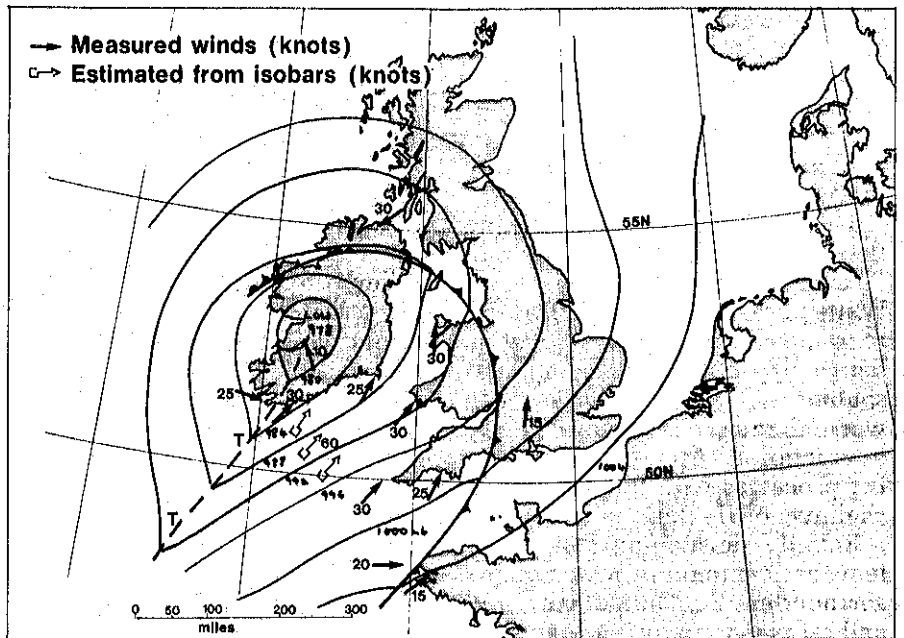
Fig. 6. The height of the storm (0400) when the violent storm-force winds (Force 11) had spread across much of the fleet. All land stations fail to record anything above 30 knots mean speed. A trough-line (T) with a 90° shift on it begins to move across the area

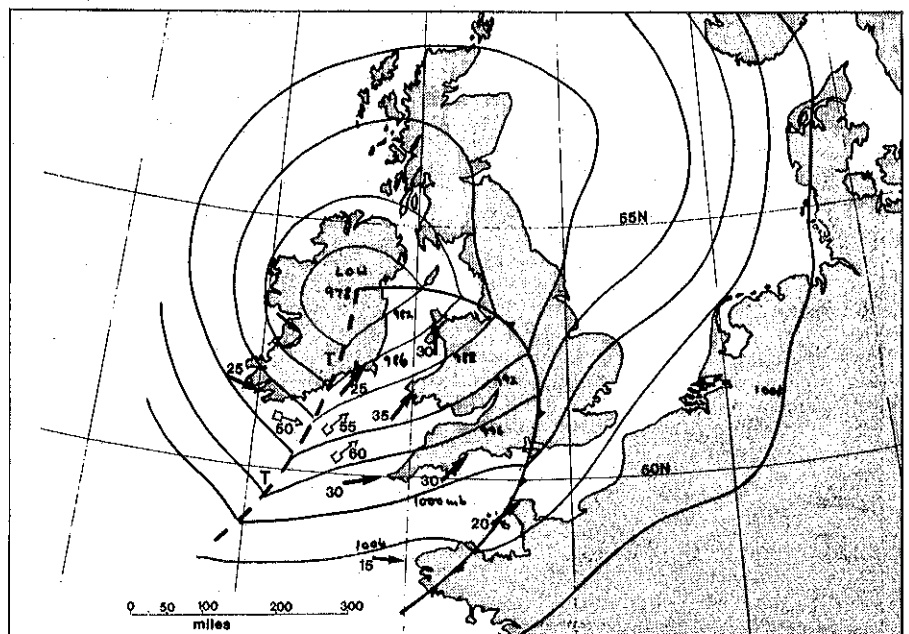
Fig. 7. Off the Rock the wind shifts and relents, but it still blows storm to violent storm force over the rescue operation. The wind drops to Force 10 behind the trough
