KP25&27 Rectification Explanation Document

Applicable Models: KP25A, KP25X, KP27A, KP27X

Document Type: Instruction Manual

Version: V1.0

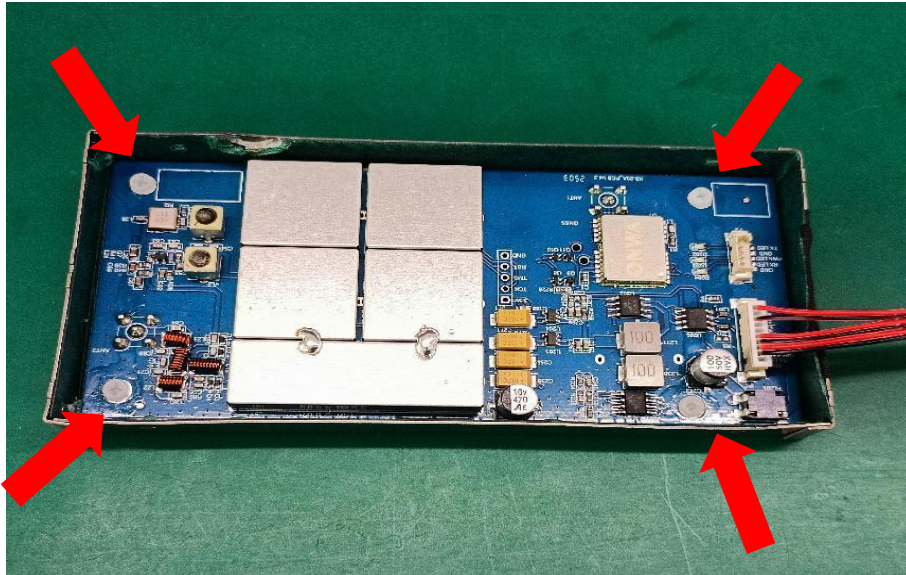
Note: The plastic screws are secured with adhesive and may be difficult to disassemble.

2.4. Use a screwdriver to remove the internal plastic screws.

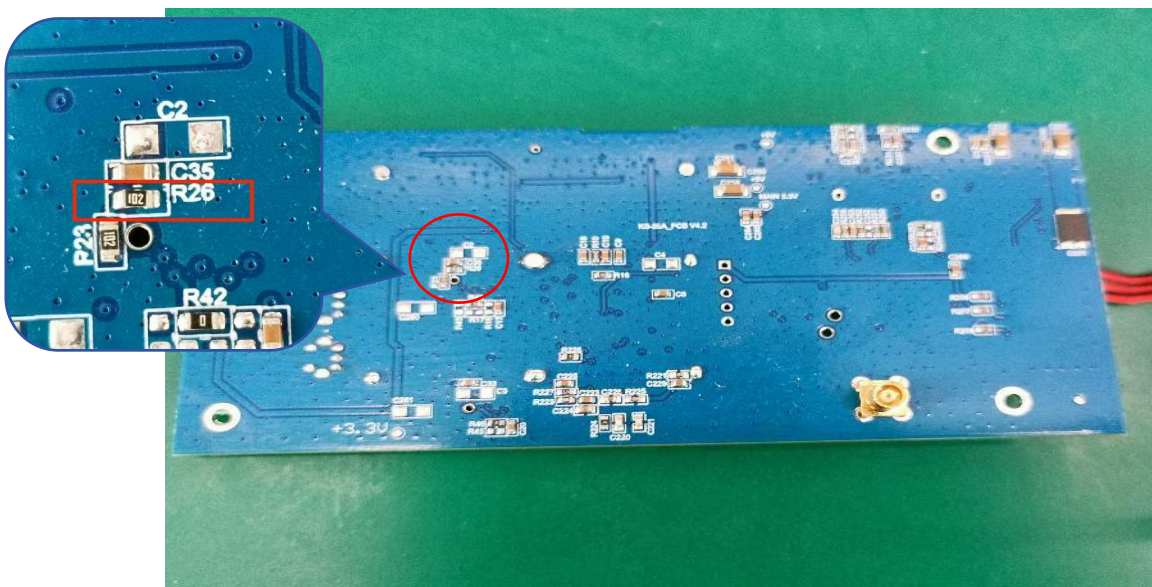
- We have identified certain deficiencies in the current product, where the AIS signals transmitted by the device fail to display the MMSI code when received by MarineTraffic base stations. These issues negatively impact user experience and require immediate corrective actions to ensure product quality and meet customer expectations.

2.5. Flip the motherboard to the back side, use a soldering iron to heat and remove resistor R26 to complete the modification.

(In special cases where a soldering iron is unavailable, diagonal cutters may be used to clip off the resistor. Avoid damaging other components during the operation.)
