Background and Introduction:

Thanks to Mark Scapens (S/V Isabella, Lagoon 440, hull # 96) Of Tauranga, NZ, I now have a step by step set of instructions on how to repair a slipping drive cone in my Yanmar SD 50 saildrive. Note: some people call it a cone drive but the Yanmar saildrive repair manual I have calls it a drive cone. Therefore, I shall be referring to it as the drive cone.

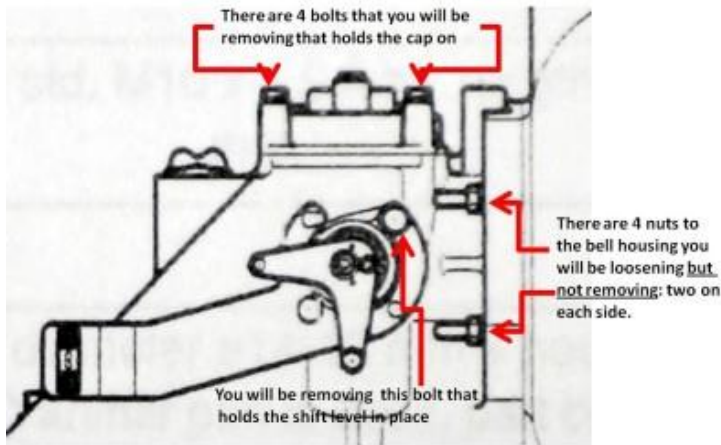
Figure 2: Close-up View Of What You Will Be Working On

Figure 1 shows the side and top view of the saildrive and highlights the area of the saildrive you will be working on. Figure 2 is a close up of the area of the saildrive you will be working on. It also shows the bolts and nuts that you will be removing or loosening. The secret of not having to separate the engine from the saildrive and then moving the engine forward is that you will just be loosening the 4 nuts at the bell housing but not removing them from the stud bolt. You then push those stud bolts forward and it backs the pinion gear and its shaft away from the drive cone assembly and allows you to remove the drive cone assembly. You will also be removing the shift lever assembly before you remove the drive cone assembly.

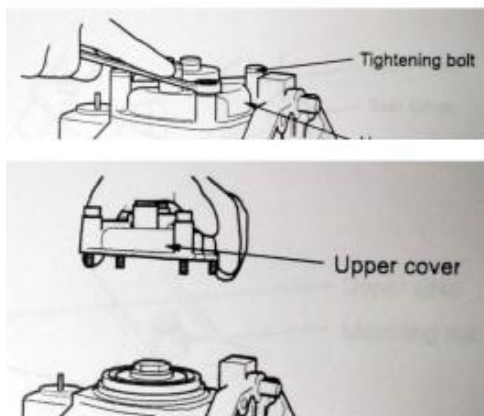
Figure 3: Step 1: Remove Upper Gear Tightening Bolts (4) And Upper Gear Cover

Figure three shows the first part of step one. Using a wrench, loosen and remove the four bolts that secure the upper cover cap. Set the bolts aside and remove the cap. Once the cap is removed, you will now want to suck or siphon out about 200 ml of gear oil from the top. You do this so that when you remove the shift lever assembly, gear oil will not run out and get things messy. Once the 200 or so ml of gear oil is removed, you are ready for step 2: removing the shift lever assembly, which is tomorrow's techno-tip of the day.

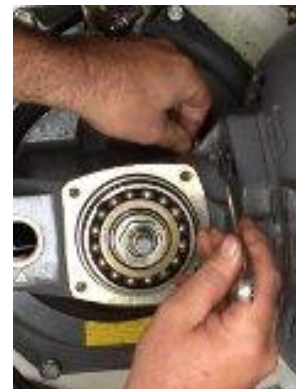
This picture is looking down onto the gear box after removal of the cover cap

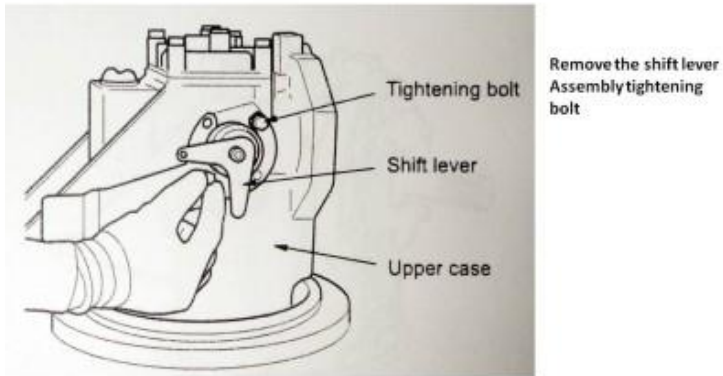
Figure 4: Step 2 Remove Shift Lever Assembly

NOTE: THE HAND IN THE FIGURE IS ON THE WRONG BOLT. YOU WANT TO REMOVE THE BOLT THAT IS LABELED "TIGHTENING BOLT".

Now that you have the gear case's upper cover off and you have lowered the gear oil level down below the shift lever orifice, it is time to remove the shift lever assembly. Figure 4 shows what you will be working on and Figure 5 shows what the shift lever assembly looks like. The shift lever assembly is fixed to the gear case by a single bolt.

Use a wrench and carefully remove it. Once the bolt is removed, carefully pull out the shift lever assembly. Be careful when you do as a spring will help push the assembly out. As you pull the assembly out, make sure you note the angle the shifter is at. When you reinsert the assembly, the shifter will need to be at the same angle that it came out at. I plan on placing mark on the side of the housing to note the position of the shifter when I pull it out. This will tell me how to position the shifter when I reassemble it.

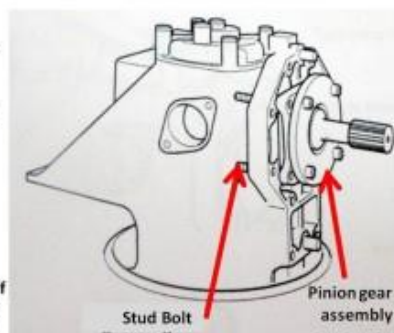
Figure 6: Step 3 Loosen Bell Housing Nuts And Push Pinion Gear And Shaft Back

The pinion gear is what transfers the engine's torque to the saildrive and is inside the bell housing

This figure has the bell housing removed and shows the pinion shaft assembly. Normally, the mechanic will separate the engine from the saildrive, back the engine off about six inches and back this pinion gear and shaft off. However, you are smarter than that! Instead, you need to only loosen the nut that is on each of the 4 stud bolts and back them off until it they are just at the end of each stud bolt. **DO NOT REMOVE THE NUTS FROM THE STUD BOLTS.** Next, using a hammer, gently tap each bolt to move the pinion gear assembly back a bit so you can easily remove the drive cone assembly (see next figure).

Now is time to do the little secret that saves you time and lots of money. The pinion gear is what transfers the engine's torque to the saildrive and is inside the bell housing. Figure 6 shows the bell housing removed and exposes the pinion shaft assembly. Normally, the mechanic will separate the engine from the saildrive, back the engine off about six inches and back this pinion gear and shaft off. This takes about half a day of his time. However, you are smarter than that! Instead, you need to only loosen the nut that is on each of the 4 stud bolts and back them off until it they are just at the end of each stud bolt. **DO NOT REMOVE THE NUTS FROM THE STUD BOLTS.** Next, using a hammer, gently tap each bolt to move the pinion gear assembly back a bit so you can easily remove the drive cone assembly

Tighten the four nuts on the stud bolts that are still in the bell housing to bring back the pinion gear assembly back into place.

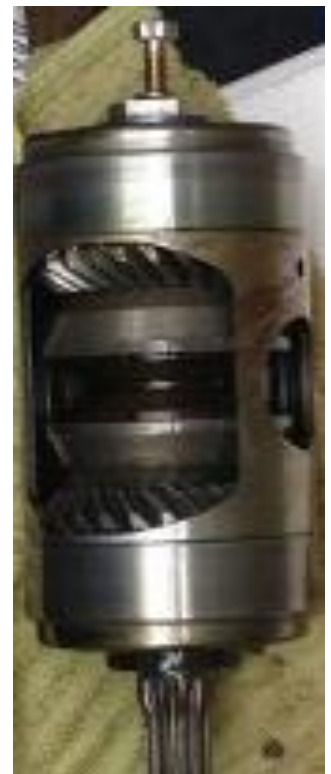
Figure 7: Step 4 Remove The Drive Cone Assembly

The figure to the left shows the exposed top part of the drive cone assembly once you remove the cap. Note the assembly nut at the top of the drive cone assembly that is still sitting in the gear housing. It is threaded at the top so you can screw one of the bolts from the upper cover into the nut at the top of the drive cone assembly to lift it out.

Figure 7 shows the exposed top part of the drive cone assembly once you remove the upper gear casing cover cap. Note the nut at the top of the drive cone assembly which is still sitting in the gear housing. It is threaded at the top. If you like, you can go ahead and buy Yanmar's special extraction tool, however, if you are clever, it really is not needed. Instead, just take one of the four bolts that you removed from the upper gear casing cover cap (see Step 1). As it turns out, it has the identical threading as the drive cone assembly's top nut. Thus, all you need to do is screw in one of those bolts, grab it with a pair of vice grips and lift the drive cone assembly out!

However, as noted above, if you just take one of the bolts from the upper cover, you can use it to screw it into the nut at the top of the drive cone assembly. Then you can use some vice grips to grab the bolt and lift the assembly out.

Before moving the assembly, use a felt pen to mark the assembly and the gearbox housing. This will assist lining up the assembly when re-inserting it (see step 8)

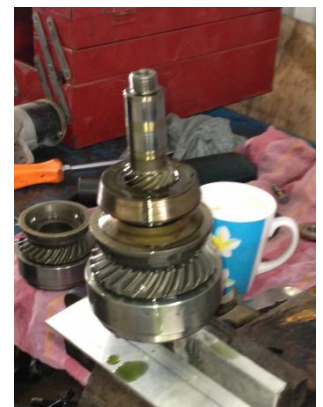
In the absence of the above, I used 2 pieces of aluminium section inserted into the vice jaws as shown in the pic....aluminium is softer than the spline...the spline wasn't damaged at all.

Once the assembly is inserted in the spline socket and you have tightened down the vice, place a wrench on the top nut (it is left handed). You may need to place the wrench handle into a pipe to get extra leverage to remove the nut. (I think a 27 ml socket fits)

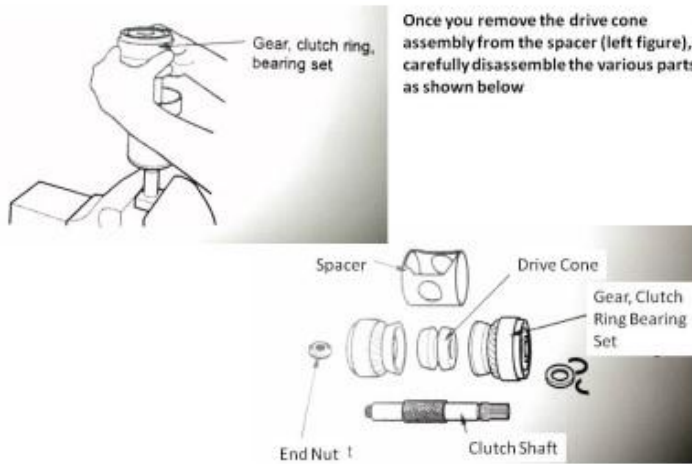
Figure 9: Step 5 Disassembling The Drive Cone Assembly, Con't.

With the nut off, you can slip off the spacer and disassemble the assembly (see Figure 9).

NOW ITS TIME TO GO SLOW!!! Make sure you use a system to layout the parts in some sort of order. We used a scribing tool to mark the "top" of the 3 gears and cone.

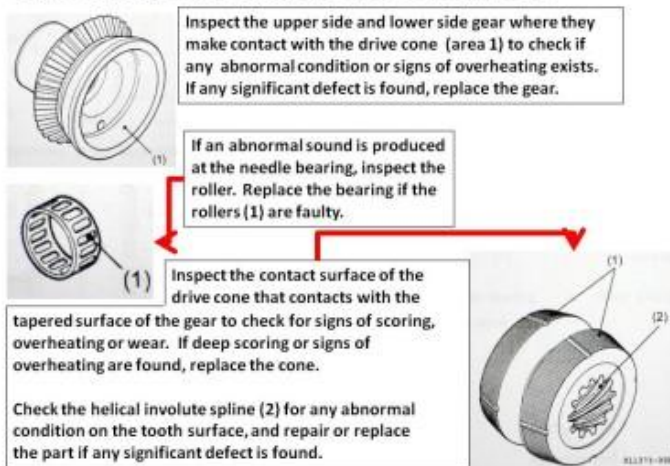
Figure 10: Step 6 Inspecting The Drive Cone And Gear

Once you have disassembled the drive cone assembly, inspect the upper side and lower side gears where they make contact with the drive cone to check if any abnormal condition or signs of overheating exists (see area 1 in the upper left hand picture in Figure 10). If any significant defect is found, you should consider replacing the gear.

Inspect the roller (see the middle picture in Figure 10) and if an abnormal sound is produced at the needle bearing this means the rolls are faulty and the bearing needs to

be replaced.

Inspect the surface of the drive cone that contacts with the tapered surface of the gear to check for signs of scoring, overheating or wear (see the bottom right picture in Figure 10). If deep scoring or signs of overheating are found, replace the cone. Oil is "squeezed" into the horizontal grooves on the cone when it's engaged. If the ridges have been worn flat, then the cone will definitely need replacement.

Check the helical involute spline (2) for any abnormal condition on the tooth surface, and repair or replace the part if any significant defect is found (see the bottom right picture in Figure 10).
