KS-200A+ Rectification Explanation Document

Applicable Models: KS-200A+

Document Type: Instruction Manual

- We have identified certain deficiencies in the current product, where the AIS signals transmitted by the device fail to display the MMSI code when received by MarineTraffic base stations. These issues negatively impact user experience and require immediate corrective actions to ensure product quality and meet customer expectations.

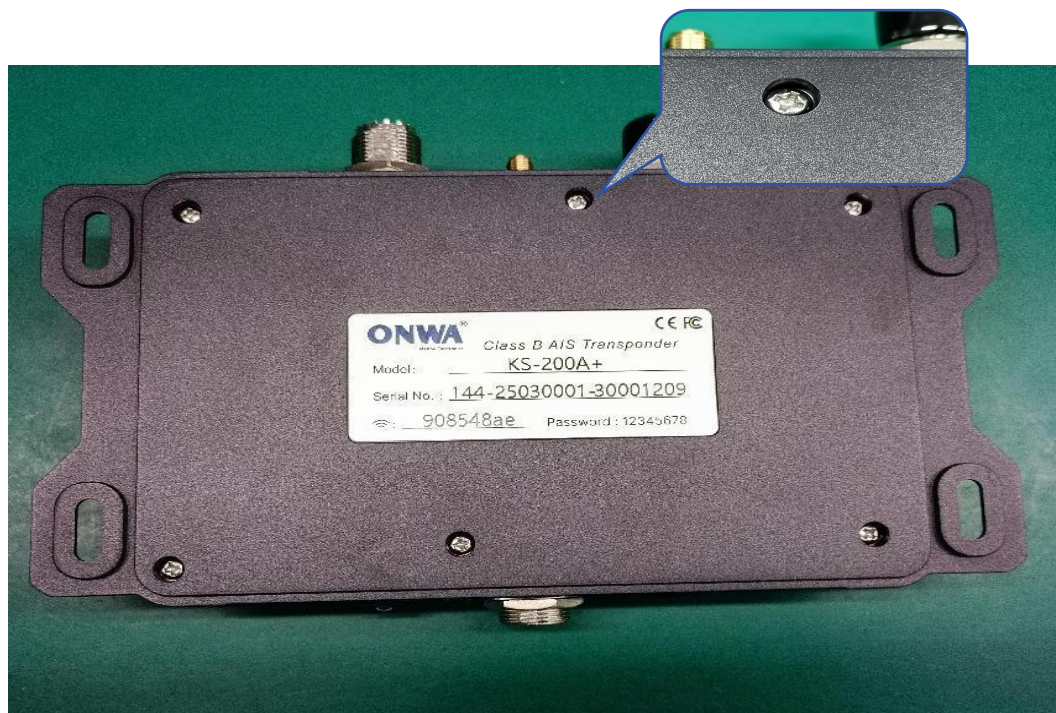
2.1 Remove the rear case screws using a screwdriver

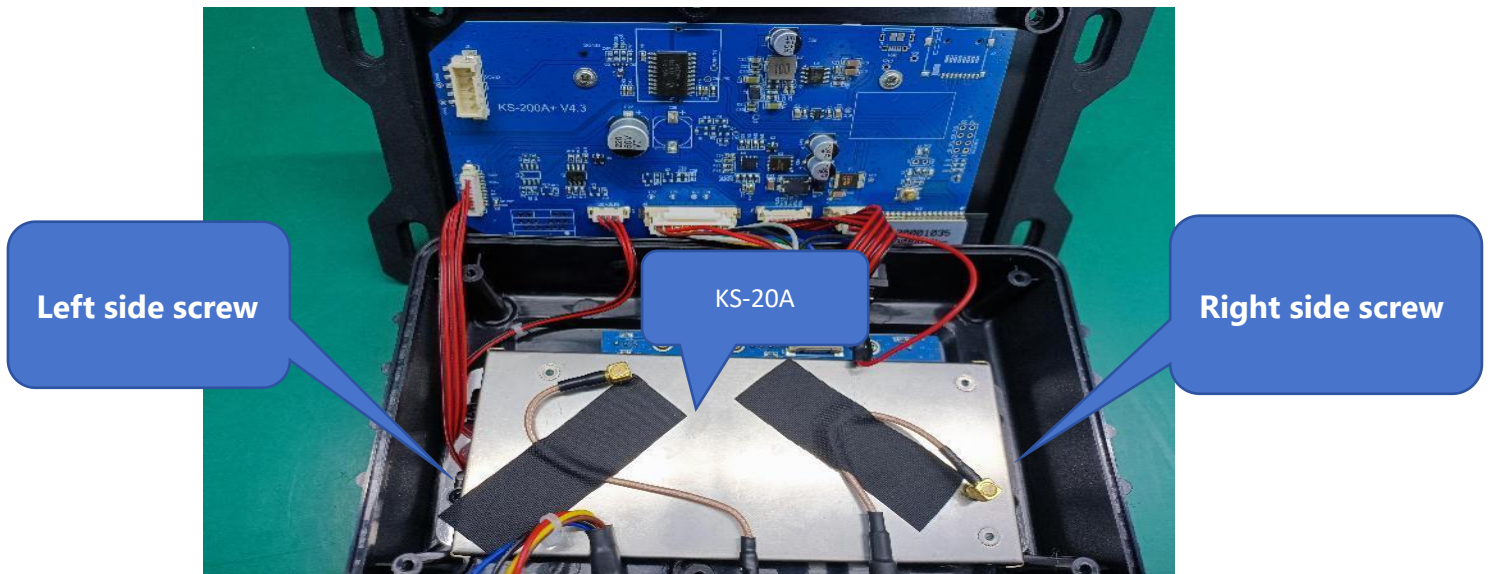
2.2 Locate the KS-20A shielding metal case and remove the screws on both sides

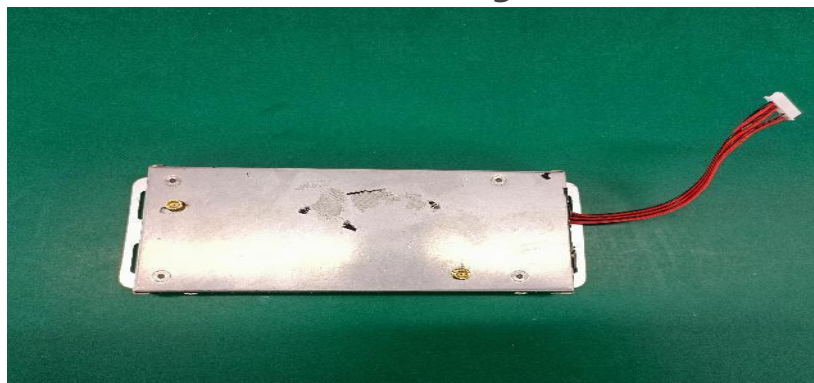
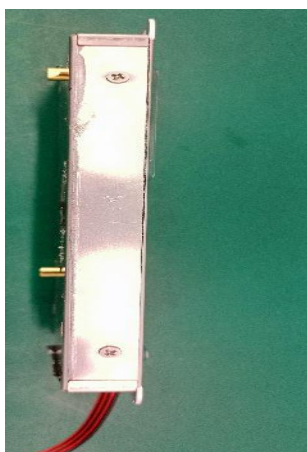
Top Screws

2.3. Use a screwdriver to remove the screws on both the top and bottom sides of the shielding metal cover.

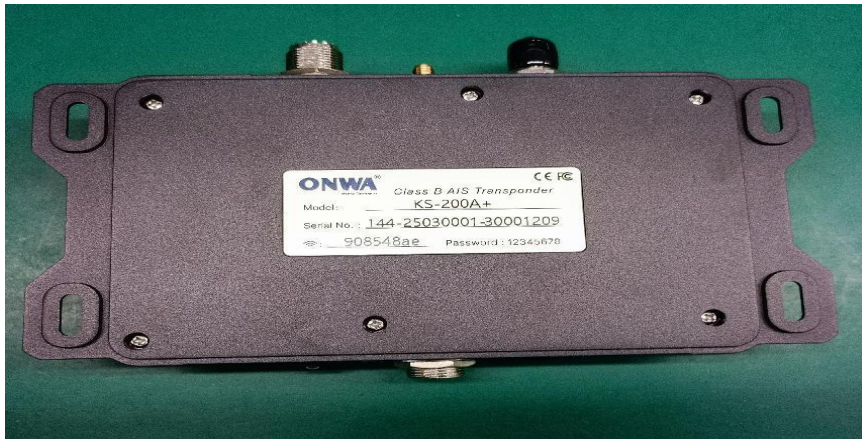
2.6 Place the motherboard back into the shielding metal casing, fasten the plastic screws, secure the shielding metal casing with screws, reinstall it into the main unit, and tighten the screws on the outer casing to complete the operation.
