Repairing the drive cone of the Yanmar SD 50

Servicing a slipping clutch

Fritze von Berswordt,
S/Y Alytes, circumnavigating 2014 - 2016

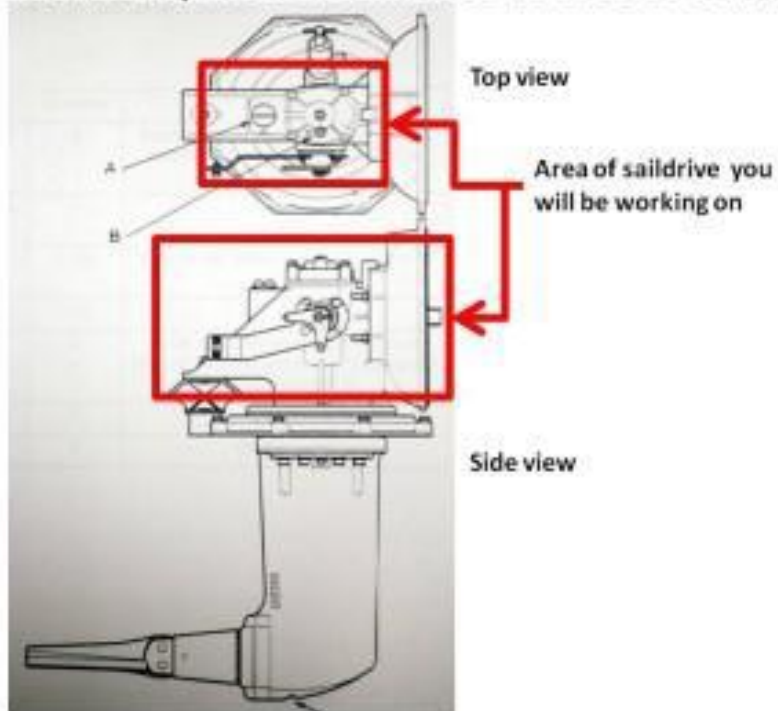
Figure 1: Side And Top View Of Yanmar SD 40 or SD 50 Saildrive

Figure 1 shows the side and top view of the saildrive and highlights the area of the saildrive you will be working on.

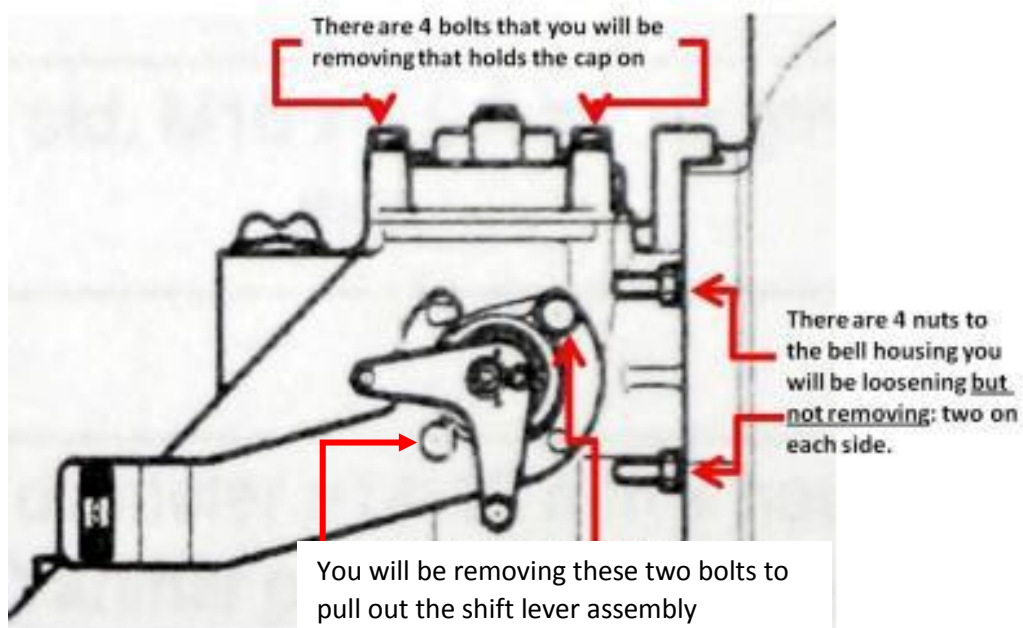
Figure 2: Close-up View Of What You Will Be Working On

Figure 2 is a close up of the area of the saildrive you will be working on. It also shows the bolts and nuts that you will be removing or loosening.

The secret of not having to separate the engine from the saildrive and then moving the engine forward is that you will just be loosening the 4 nuts at the bell housing but not removing them from the stud bolt. You then push those stud bolts forward and it backs the pinion gear and its shaft away from the drive cone assembly and allows you to remove the drive cone assembly.

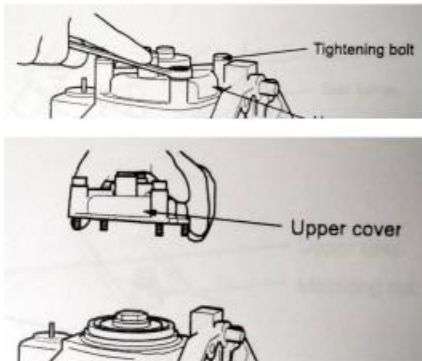
Figure 3: Step 1: Remove Upper Gear Tightening Bolts (4) And Upper Gear Cover

Figure 3 shows the first part of step one. Before actually opening the cap, it is recommended to pump or siphon out about 200 ml of gear oil. Some sailors did this after removing the cap, we drained oil through the dipstick opening before opening the housing. In any case, you do this so that when you remove the shift lever assembly, gear oil will not run out and get things messy.

Using a wrench, loosen and remove the four bolts that secure the upper cover cap.

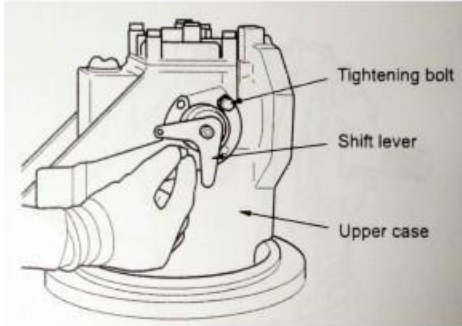
Figure 4: Step 2 Remove Shift Lever Assembly

Figure 4 shows what you will be working on and Figure 5 shows what the shift lever assembly looks like.

Remove the two shift lever tightening bolts

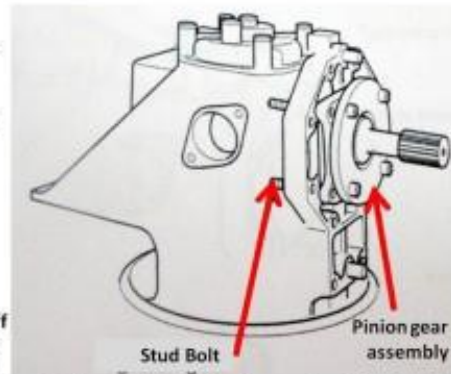
Figure 6: Step 3 Loosen Bell Housing Nuts And Push Pinion Gear And Shaft Back

This figure has the bell housing removed and shows the pinion shaft assembly. Normally, the mechanic will separate the engine from the saildrive, back the engine off about six inches and back this pinion gear and shaft off. However, you are smarter than that! Instead, you need to only loosen the nut that is on each of the 4 stud bolts and back them off until they are just at the end of each stud bolt. **DO NOT REMOVE THE NUTS FROM THE STUD BOLTS.** Next, using a hammer, gently tap each bolt to move the pinion gear assembly back a bit so you can easily remove the drive cone assembly (see next figure).

Figure 6 shows the bell housing removed and exposes the pinion shaft assembly.

You need to only loosen the nut that is on each of the 4 stud bolts and back them off until they are just at the end of each stud bolt. They should be backed in a way that the end of the bolt is slightly (really just barely) recessed in the nut. So the nut protects the bolt's threading in the next step.

Next, using a hammer, gently tap each nut/bolt to move the pinion gear assembly back a bit so you can easily remove the drive cone assembly. Do not hit the bolts with a hammer directly, as this would damage the threads.

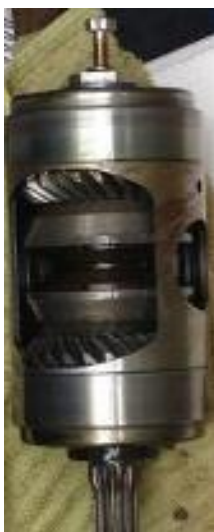
In the picture to the left you see the extracted drive cone assembly. Notice the bolt on the top of the assembly, it is one of the bolts that used to tighten the cap (step 1).

Also note the rather large nut, in which the bolt mentioned above is inserted. This will be important in the next steps and is actually a tricky bit of hardware.

Be patient and lift it out slowly and ideally absolutely straight. The assembly is very tightly fitted into its housing. If you tilt it too far in one direction while lifting it, it may get stuck.

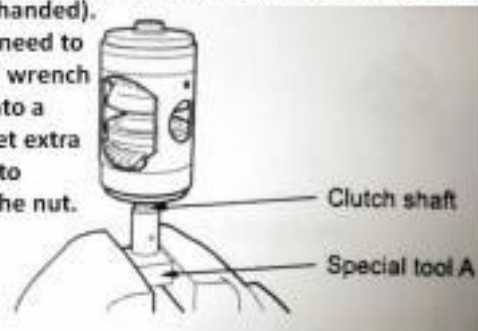
The best way would be to insert the clutch shaft into a spline socket so you can insert the socket into the vice without damaging the splines on the shaft.

I am not sure what size of spline socket you need but you can buy a universal spline socket set from Sears for under \$40. Or, you can buy Yanmar's "Special Tool A" but it is very expensive.

In the absence of the above, both Mark (S/V Isabella) and Fritze (S/V Alytes) used 2 pieces of aluminum section inserted into the vice jaws as shown in the pic....aluminum is softer than the spline...the spline wasn't damaged at all.

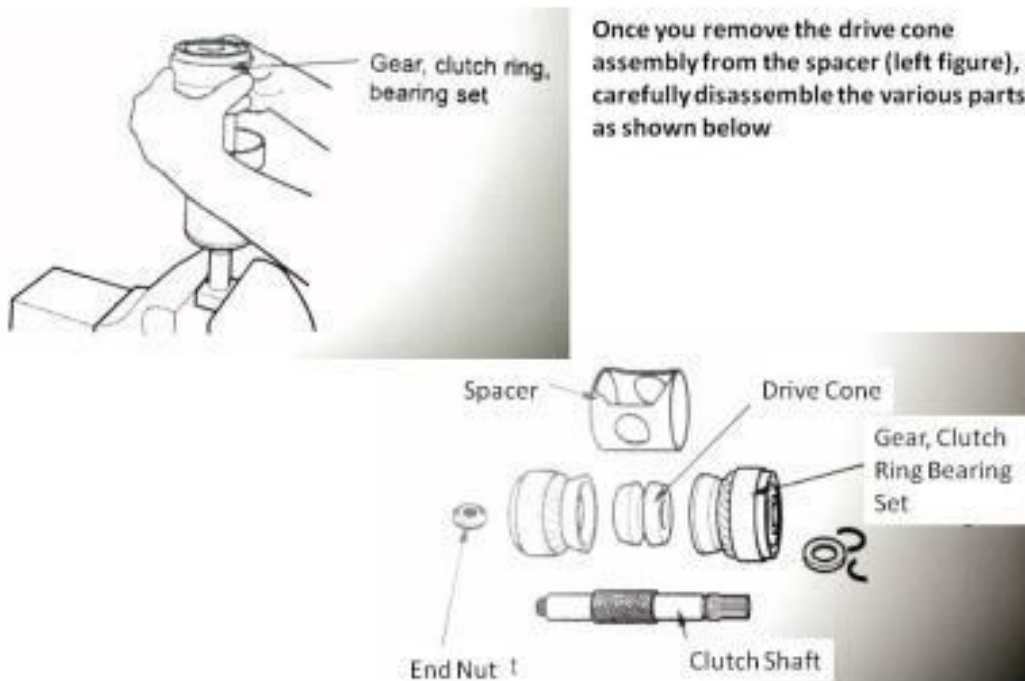
Figure 9: Step 5 Disassembling The Drive Cone Assembly, Con't.

With the nut off, you can slip off the spacer and disassemble the assembly (see Figure 9).

NOW ITS TIME TO GO SLOW!!! Make sure you use a system to layout the parts in some sort of order. We used a scribing tool to mark the "top" of the 3 gears and cone.
