1979
**FASTNET RACE
INQUIRY**

ROYAL YACHTING ASSOCIATION • ROYAL OCEAN RACING CLUB

REPORT

THE COUNCIL OF THE RYA AND THE COMMITTEE OF THE RORC

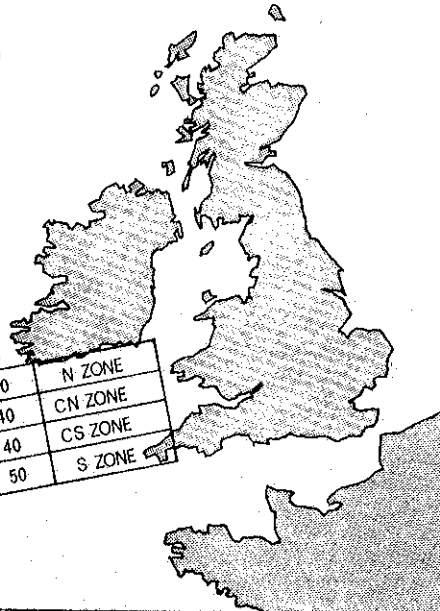
Fig. 2. By dividing the race area into northern, central northern, central southern and southern zones and measuring the distance apart of the isobars, the gradient wind speed (the speed at a level clear of surface friction) can be given between 1300 Monday and 1300 Tuesday. Take two thirds of these speeds as representative of mean speeds at yacht level, but individual gusts can be up to gradient speed

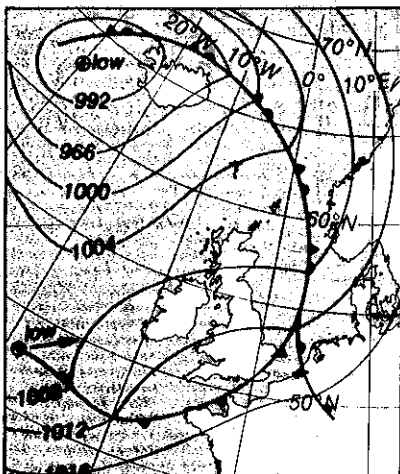
Figure 1: 1200 GMT Monday—
storm center 1007 millibars

As a preceding storm system became stationary southwest of Iceland, the weak storm raced eastward across the Atlantic over the weekend, reaching a position near 48°N, 19°W by 1200 Greenwich Mean Time (GMT), Monday, August 13, with a central pressure of about 1007 millibars (Fig. 1).

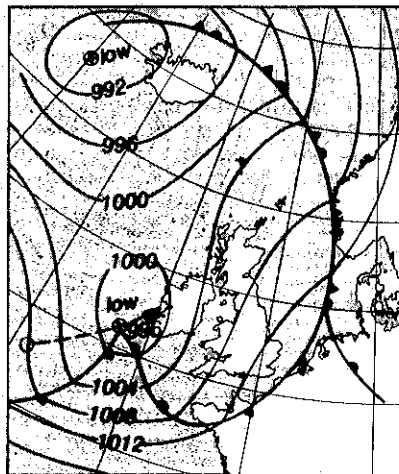
Figure 2: 1800 GMT Monday—
storm center 996 millibars

During the six hours from 1200 to 1800 GMT, the storm began to intensify and move rapidly east-northeast. By 1800, the central pressure had dropped to about 995 millibars, and the storm center was near 51°N, 13°W (Fig. 2). It was between 1500 and 1800 GMT Monday that questions about the storm's potential development were

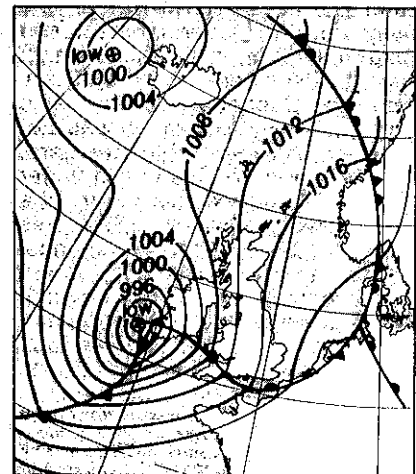
Figure 3: 2100 GMT Monday—
storm center 983 millibars

The weather map for 2100 GMT (Fig. 3) shows the truly explosive development that was under way within the decelerating storm system. Valentia, on the southwest Irish coast, reported a pressure of 989 millibars and winds gusting to 48 knots. The rapidly developing pressure gradient suggests that gusts of 50 or 60 knots were already being felt over the water south of Ireland, eastward to around 7°W. These higher winds generally occur ahead of a developing storm in the region of maximum pressure falls, and again behind the storm and its associated cold front in the rapidly rising pressures. The latter region is apt to provide the strongest pressure gradient along with a wind

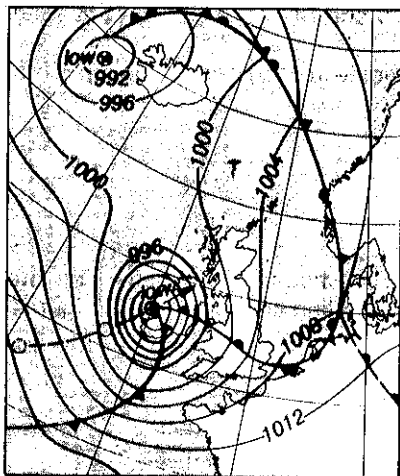
Figure 4: 0000 GMT Tuesday—storm center 979 millibars

By midnight GMT (Fig. 4) the storm center was off Galway Bay with a central pressure near 980 millibars, which then held fairly steady for the next six hours. The associated cold front had moved to a position just east of Fastnet Rock, where the rapidly rising pressure gradient created Force 10 and higher winds from the west-southwest.

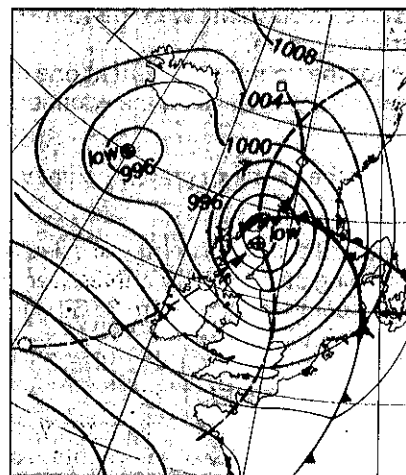
Figure 6: 1200 GMT Tuesday—storm center 983 millibars

By 1200 GMT Tuesday, the storm had moved on to the Moray Firth off northern Scotland, heading for the Shetland Islands (Fig. 6). The squares to the north of the storm center in Figure 6 represent the continued six-hour plots as the storm moved on toward the Norwegian Sea. This retreat from the scene allowed sea conditions to subside over the area, which permitted the widespread deployment of air/sea rescue units to aid the stricken yachts. Had the storm lingered on for several days, the toll would very likely have been even more staggering.
